March 29, 2006
BCI Project No. 19-14067

**RE: 2006 Annual Dam Inspection
Lake Grady Dam
Hillsborough County, Florida**

BCI Project No. 19-14067
2006 Annual Dam Inspection
Lake Grady Dam

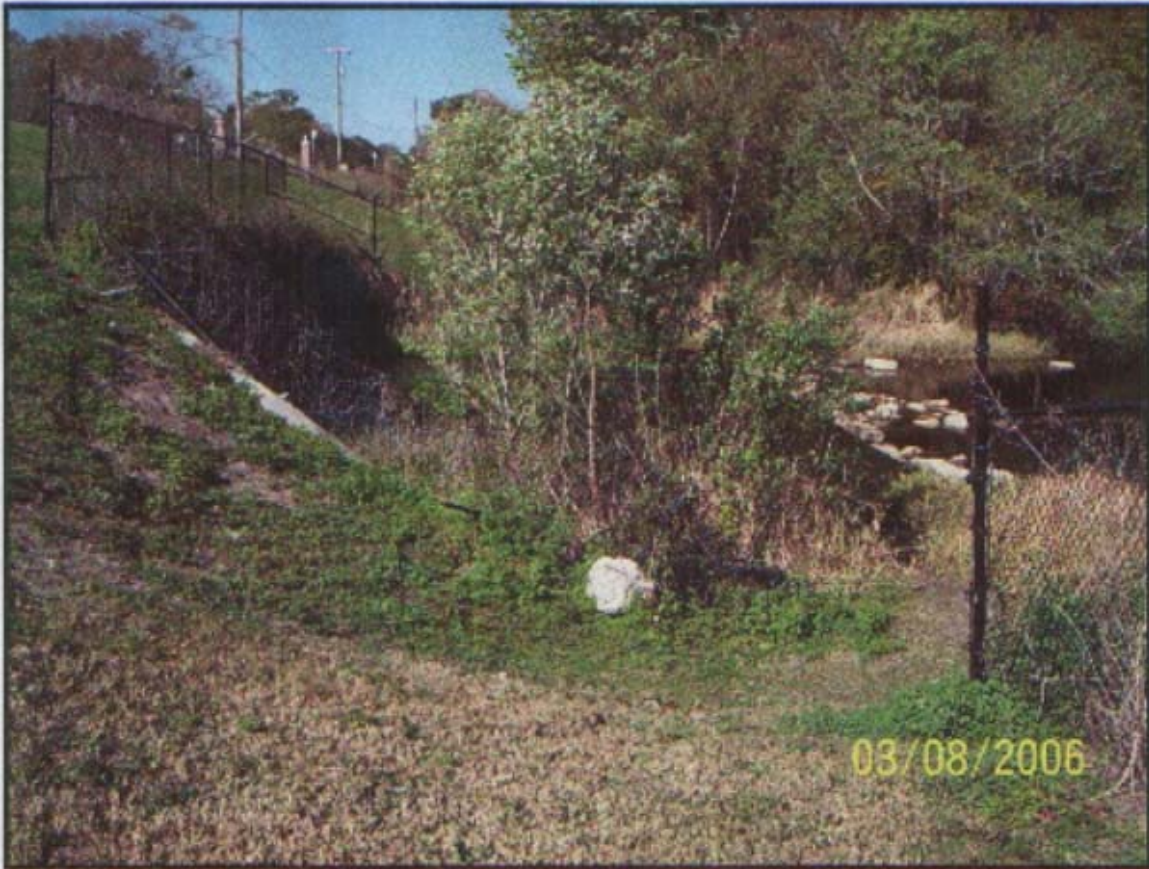
Photo 1

The downstream end of the spillway discharge was accessible through a section of missing fence (**Photo 1**). The downstream discharge appeared in good working condition and clear of debris which could affect discharges (**Photo 2**).

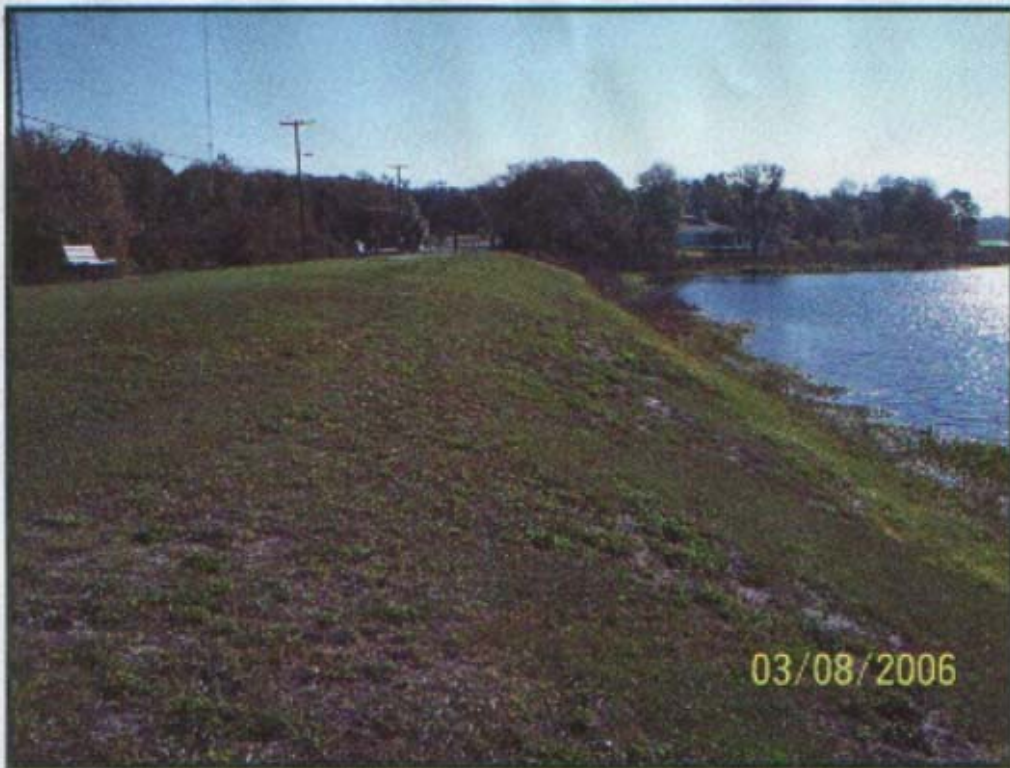
Photo 3

In general, a visual inspection of the upstream slope performed on foot indicates that it is in good condition (**Photo 3**). A majority of the embankment is well vegetated. Visual observations indicated areas where the vegetation is missing, likely due to the ruts created during mowing. These areas should be established with vegetation to prevent future erosion. Near the west abutment, some minor soil erosion was observed on the upstream slope. This is likely due to rainfall runoff from the road located along the crest. A drain within the pavement appears to contain large amounts of sediment which may be hindering the proper drainage of water from the roadway into the lake, causing overflow and erosion of the surrounding soils. The catch basin for the roadway drain should be cleaned out to prevent it from overflowing onto the embankment (**Photo 4**).

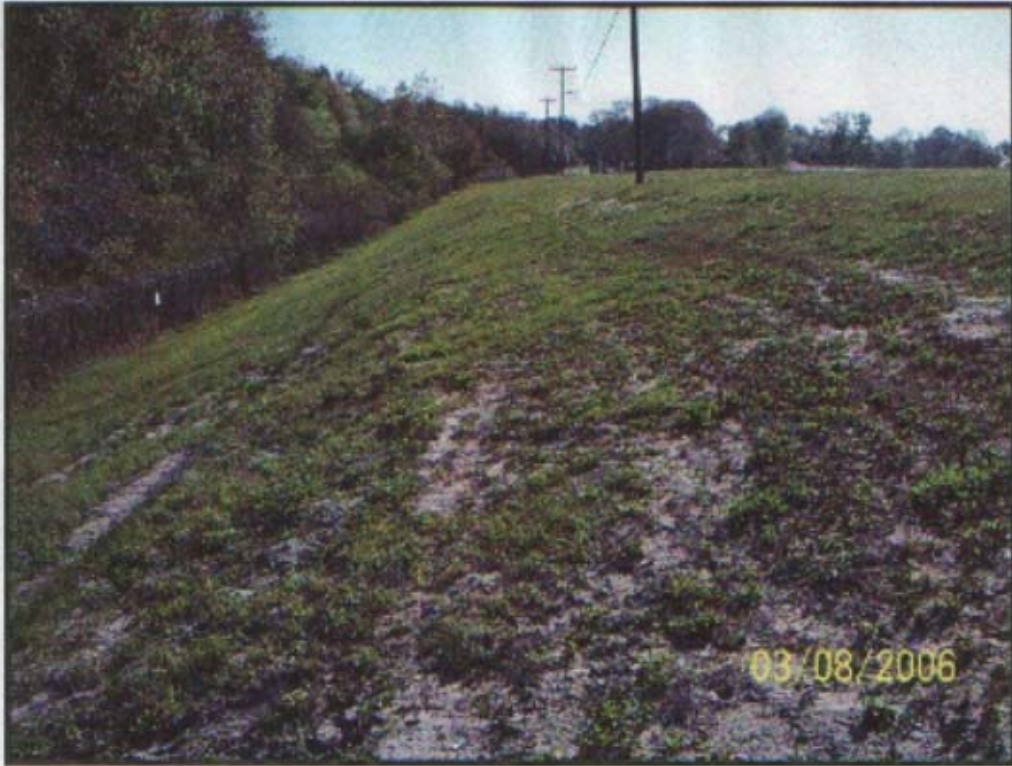
Photo 5

The downstream slope was inspected as well by walking and making visual observations. Observations of the downstream slope indicate the embankment is in good condition (**Photo 5**). A fence was present at the toe of the slope and the downstream area was heavily vegetated preventing visual observation of the area. The zone of soil erosion noted in the 2002 inspection report, located on the downstream slope, approximately 1/3 of the way along the dam from the western abutment, has been repaired and grassed.

The grass appears in good condition on the downstream slope with sparsely vegetated areas observed along the alignment, likely due to the ongoing mowing operations.

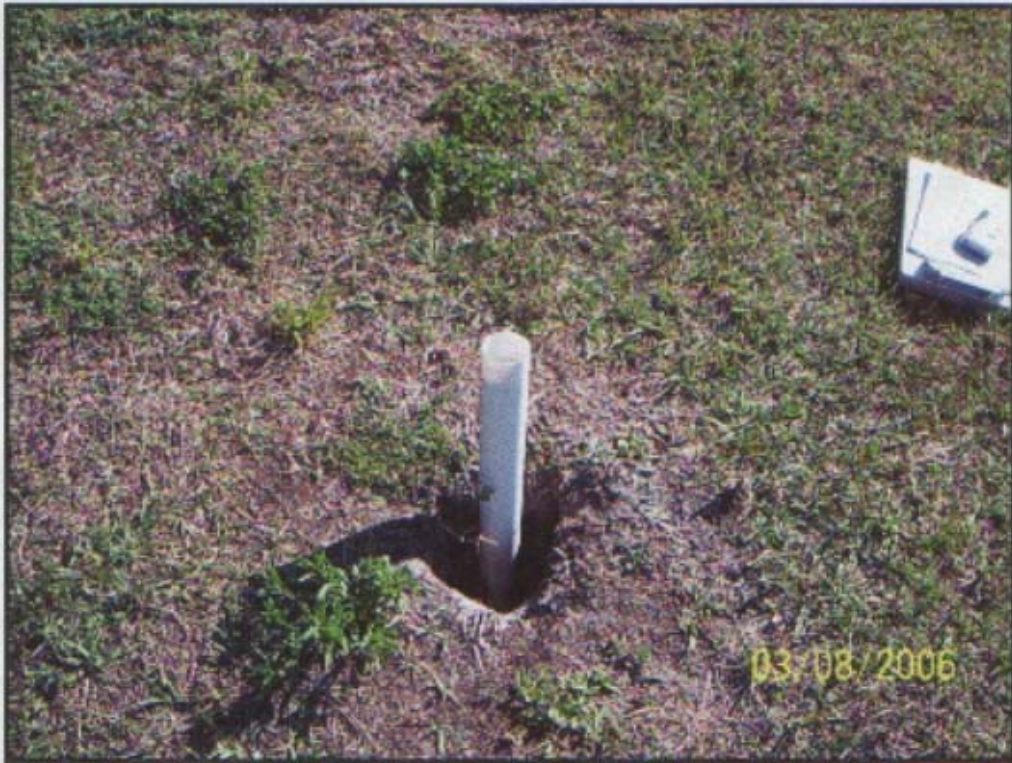
Photo 6

In addition, two piezometers were identified within the dam. The piezometer locations are shown on **Figure 1**. The piezometers do not appear to be in working condition (**Photo 6**).
