Saturday, June 07, 2008

Dam Inspection Report

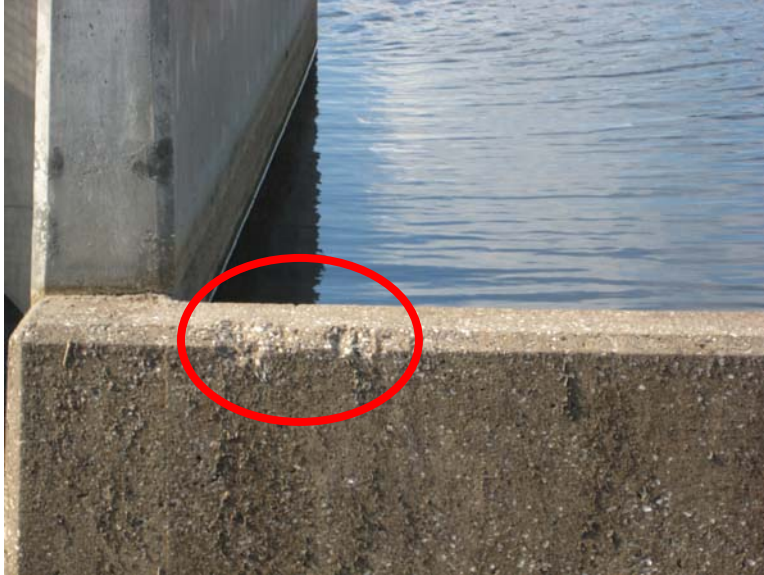
General condition	<input type="checkbox"/>	Good
	<input checked="" type="checkbox"/>	Fair
	<input type="checkbox"/>	Poor
	<input checked="" type="checkbox"/>	Concrete deterioration

Item 5a. Concrete erosion/scarring.

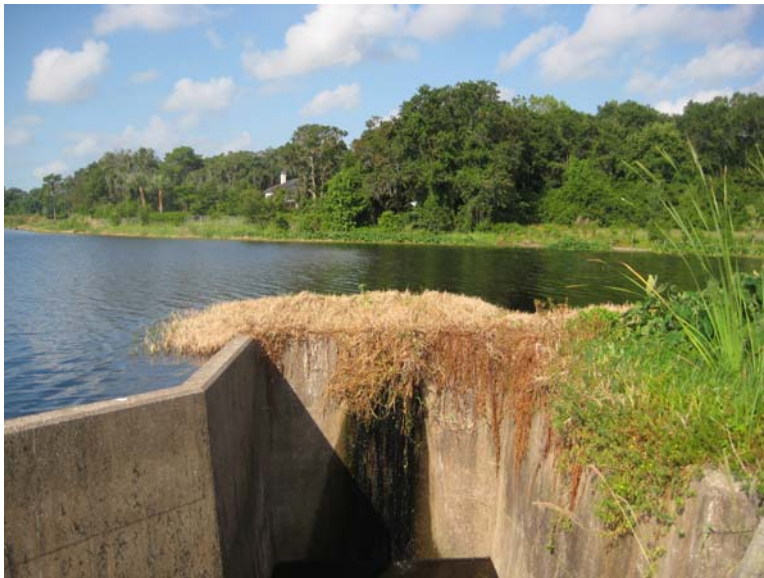
Wier	<input type="checkbox"/>	Clear
	<input type="checkbox"/>	Obstructed
	<input checked="" type="checkbox"/>	Clogged

Minor erosion noted at the top of box culvert wall near inlet box on west side. Vegetation clump removed and moved into spillway. Wier to be observed at next inspection after rains have had a chance to raise the lake level.

Item 5b. Wier obstruction.

*Residents should be reminded to collect feces from their animals.
 Decision to clear wier to be discussed at next directors meeting
 Organize a community service project to retrieve downstream barriers.
 Re-install 4x4 barrier posts at west end of dam property.
 Patch concrete on concrete apron.
 Restore electrical operation of sluice gate.
 Contact BCI to learn more about piezometer operation and repair.*

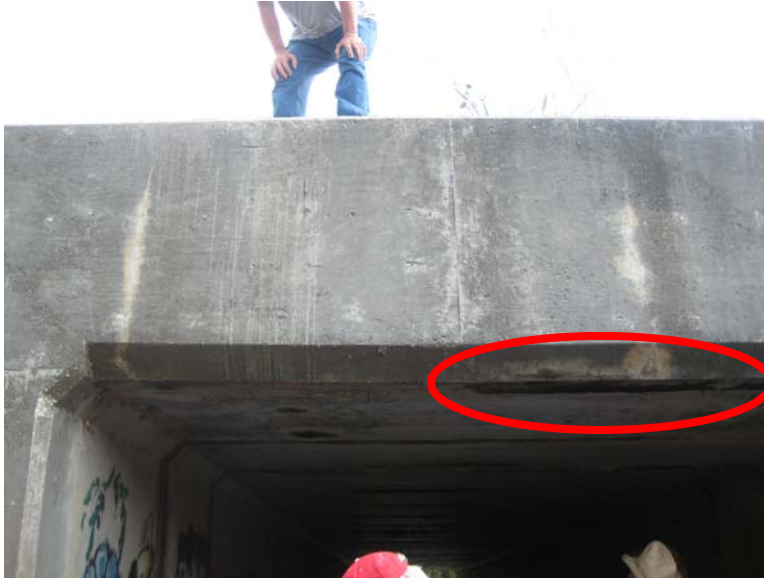
General condition	<input checked="" type="checkbox"/>	Good
	<input type="checkbox"/>	Fair
	<input type="checkbox"/>	Poor
Culvert Joints at Base	<input checked="" type="checkbox"/>	Minor seepage
	<input type="checkbox"/>	Drip
	<input type="checkbox"/>	Trickle
	<input type="checkbox"/>	Faucet flow
	<input type="checkbox"/>	Concrete deterioration
Box Section Joints	<input checked="" type="checkbox"/>	Minor seepage
	<input type="checkbox"/>	Drip
	<input type="checkbox"/>	Trickle
	<input type="checkbox"/>	Faucet flow
	<input type="checkbox"/>	Concrete deterioration

Slight shifting of box panels.

Item 6. Minor seepage.

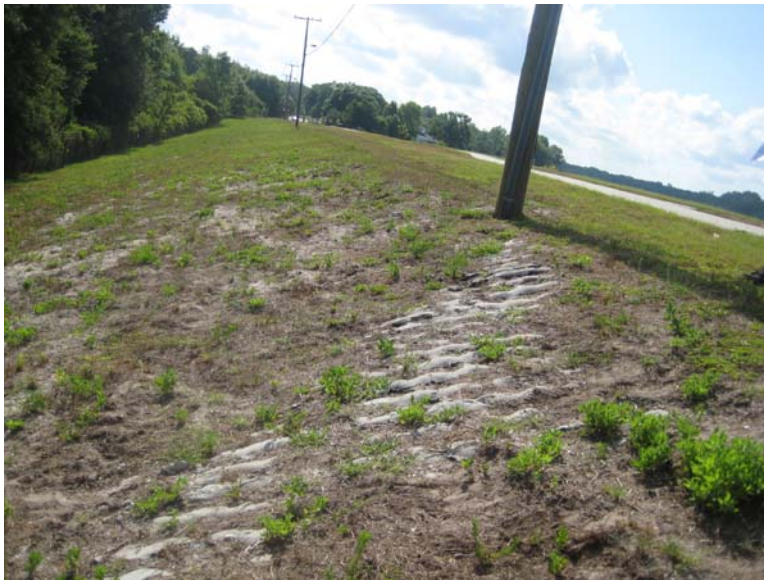
General Upslope Condition	<input type="checkbox"/>	Good
	<input checked="" type="checkbox"/>	Fair
	<input type="checkbox"/>	Poor
General Downslope Condition	<input type="checkbox"/>	Good
	<input type="checkbox"/>	Fair
	<input checked="" type="checkbox"/>	Poor
Erosion - Upslope	<input type="checkbox"/>	None
	<input checked="" type="checkbox"/>	Minimal
	<input type="checkbox"/>	Trail
	<input type="checkbox"/>	Gulley
Erosion - Downslope	<input type="checkbox"/>	None
	<input checked="" type="checkbox"/>	Minimal
	<input type="checkbox"/>	Trail
	<input type="checkbox"/>	Gulley
Dam Integrity (Downslope)	<input checked="" type="checkbox"/>	Good
	<input type="checkbox"/>	Seepage Noted
	<input type="checkbox"/>	Trickle
	<input type="checkbox"/>	Flow

Conditions should improve with rain.

Mainly due to lack of rain and improper trimming of grass.

Item 8. Downslope erosion.
