Saturday, March 14, 2009

Behrens, Akhter, Porter, Joszi, Cutler

## Dam Inspection Report

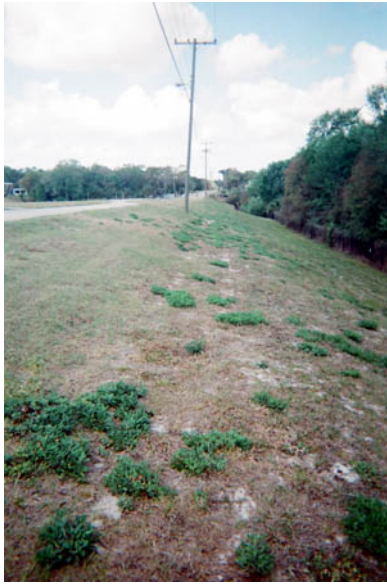
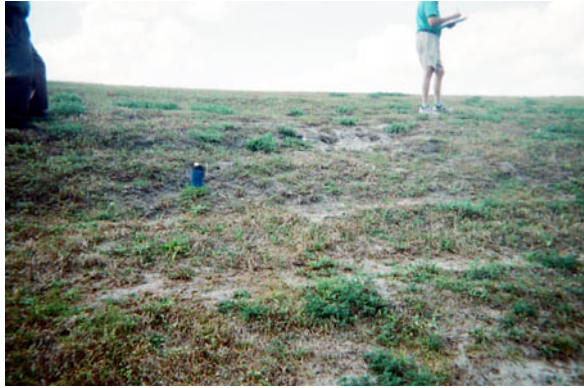
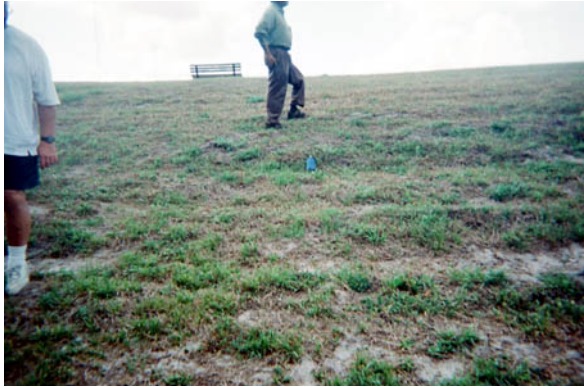
*Mowing tractors operating on dam slopes have cut gulleys into both sides of the dam. Recommendations to the SRHOA for ceasing of mowing by vehicle outside of 10 feet from sidewalk.*

*Ruts on north side of dam*

*Concrete seam deterioration at junction of common area apron and spillway structure. Recommend to SRHOA that mowing vehicles be prohibited outside of ten feet from sidewalk. Remove trees on south side of dam. Remove vegetation in culverts and discharge apron at next rainfall. Repair fences.*

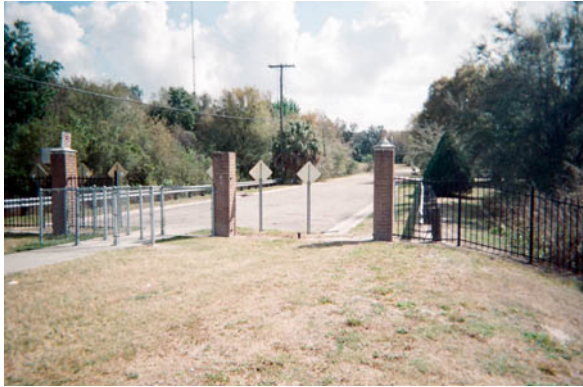
*Missing fence on east side of dam*

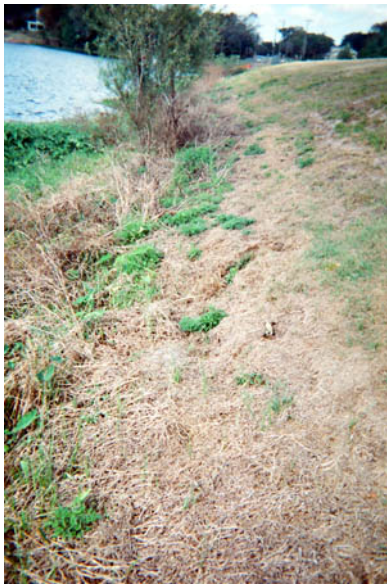
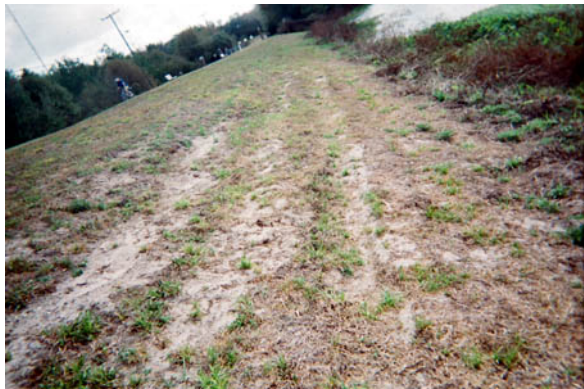
*Ruts on south side of dam*

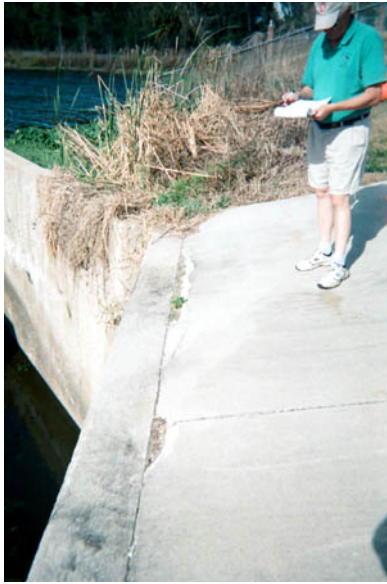
*Cracked concrete seams*

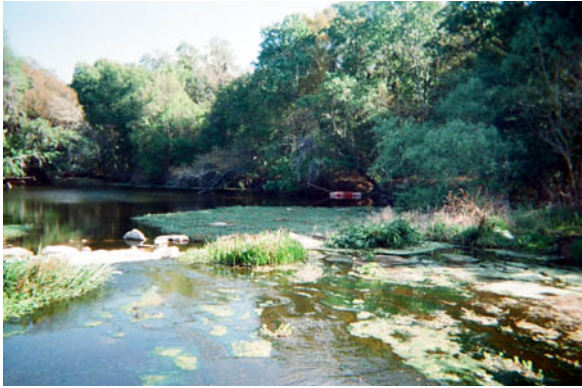
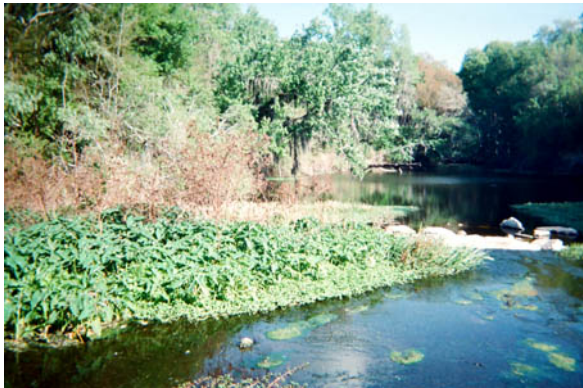
*Water vegetation on discharge apron.*

*Vegetation on discharge apron*

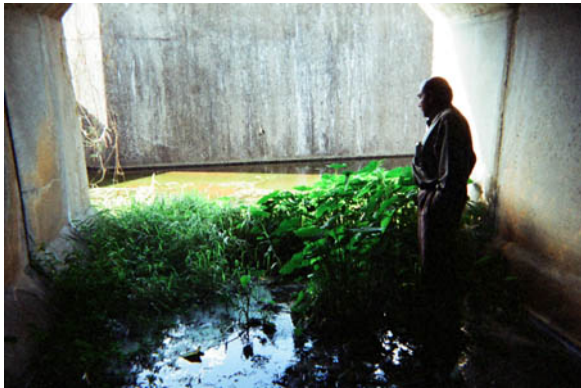
*Water vegetation blocking #1 (east) inlet. No seepage noted due to dry weather conditions.*

*Vegetation at culvert #1 (east) inlet*

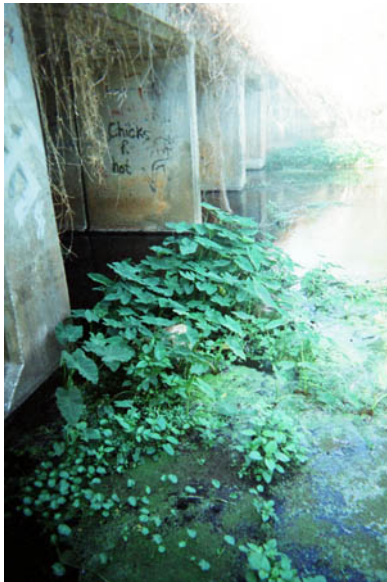
*Vegetation at culvert #4 (west) inlet*
