## SINKHOLE FORMATION AT LAKE GRADY, FLORIDA

*Joseph D. Haber<sup>1</sup>, G. Mayfield<sup>2</sup>*

Southwest Florida Water Management District

### ABSTRACT

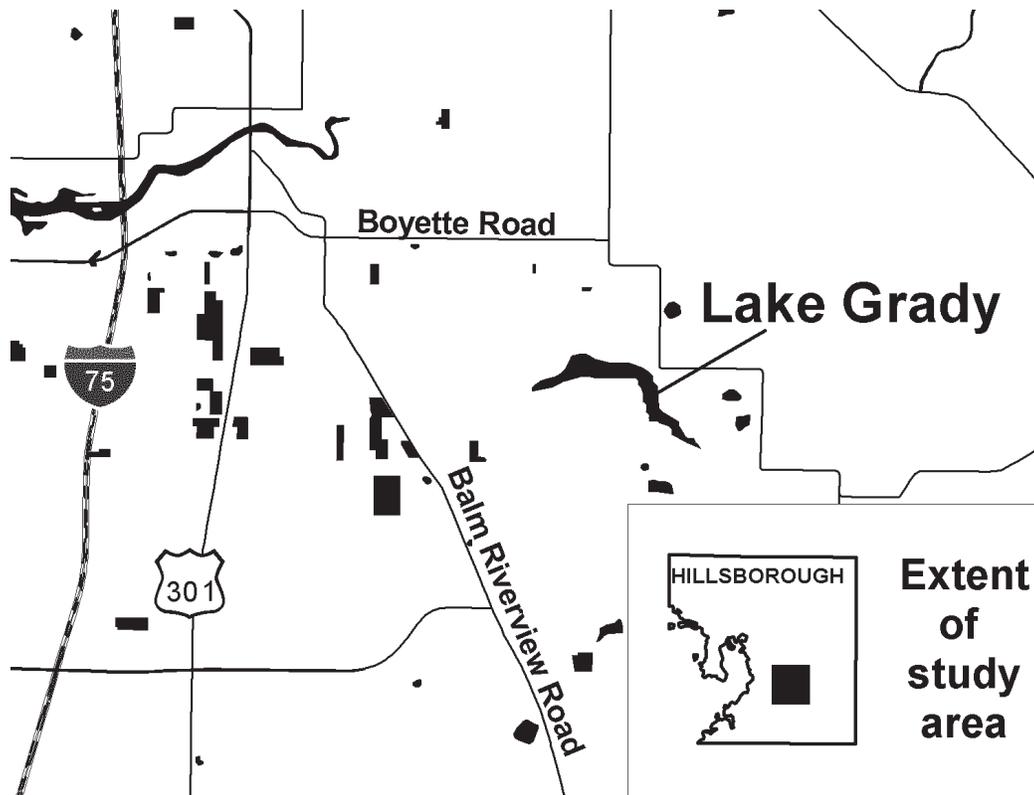
**Figure 1:** Reference map of study area.

Lake Grady is a 184-acre man-made lake that was created in 1969 by the impoundment of Bell Creek with an earthen and concrete dam (Figure 1). The original Lake Grady impoundment structure was constructed under a Southwest Florida Water Management District (SWFWMD) General Works of the District (W.O.D.) Permit. The purpose of the structure was to create a lake for use by residents

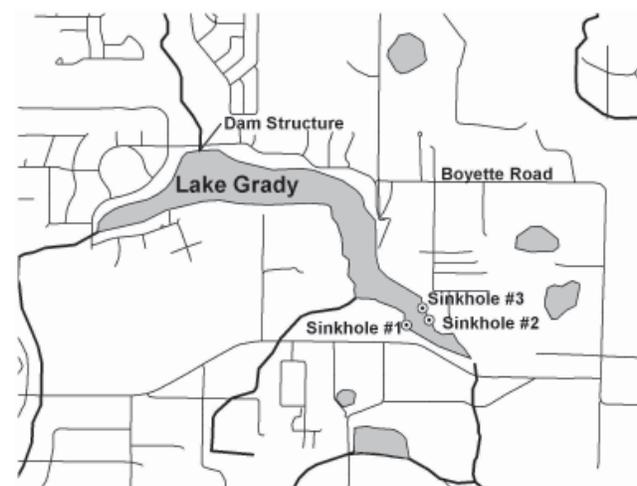
**Figure 2:** Location of sinkholes in Lake Grady.

Our report, like many of the past investigations, concentrates on the sinkhole that opened in March 2000. This sinkhole is known as Sinkhole #2 in the literature. As the name suggests, it was not the only sinkhole to form within the lake (Fig. 2). A similar but less-documented incident occurred in April 1974, when a sinkhole (Sinkhole #1) opened and wells were contaminated. A third sinkhole (Sinkhole #3) formed within the lake in May 2001. This sinkhole was smaller and did not penetrate the underlying aquifer. Sinkhole #2 is located in Section 36, T30S, and R20E and is located approximately 400 - 500 feet to the ENE of Sinkhole #1 (Cardinale, 2000).

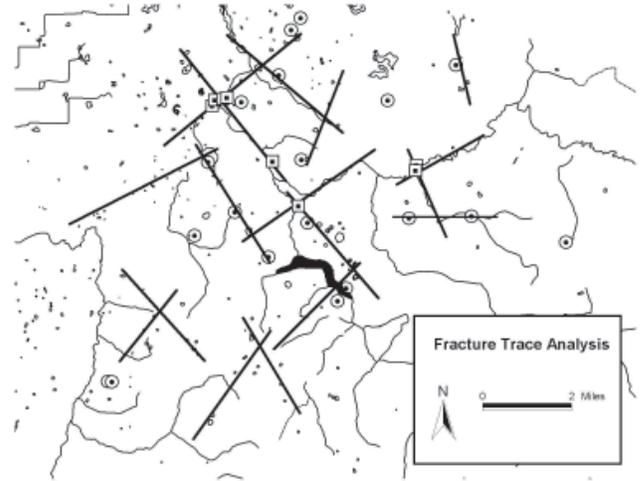
In 2002, the SWFWMD identified photolines throughout the study area. The photolines included closed depressions, internally drained basins, and several springs. This study placed a photolinear composed of a series of surface-closed depressions (including Sinkholes 1-3 in Lake Grady) through the southeastern section of the lake (Fig. 3).

**Figure 3:** Fracture trace analysis (SWFWMD, 2002). Squares denote locations of springs. Circles denote location of sinkholes. Lines denote photolines.

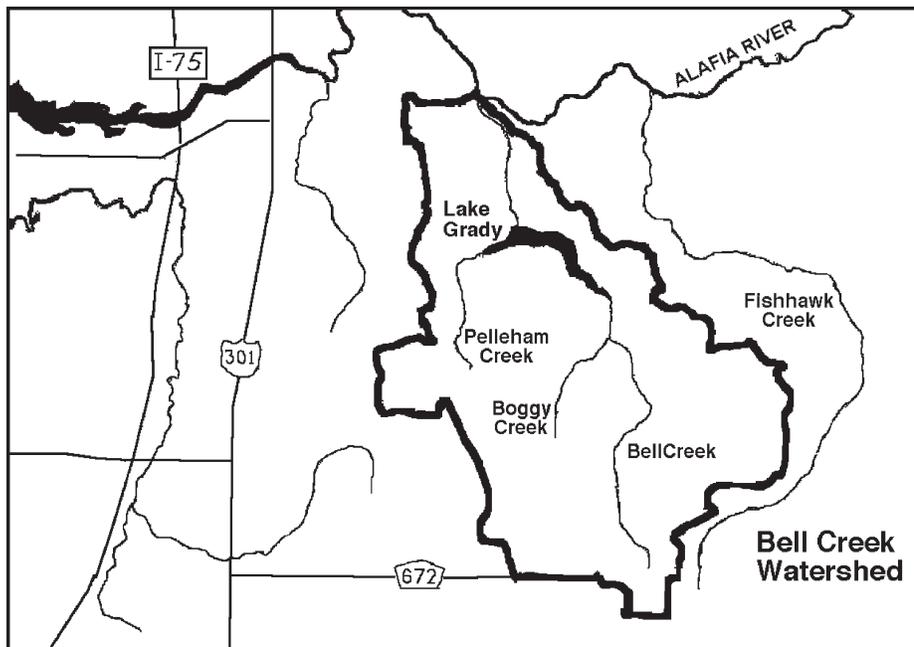
Figure 4 : Bell Creek Watershed (modified from Parsons, 2002).

Bell Creek, a tributary to the Alafia River, flows from south to north and drains an area of approximately 12,600 ac at its confluence with the Alafia River (Fig. 4). Boggy Creek and Pelleham Creek are the two main tributaries to Bell Creek. Boggy Creek flows into Bell Creek upstream of Lake Grady, while Pelham Creek flows directly into the western lobe of the Lake.

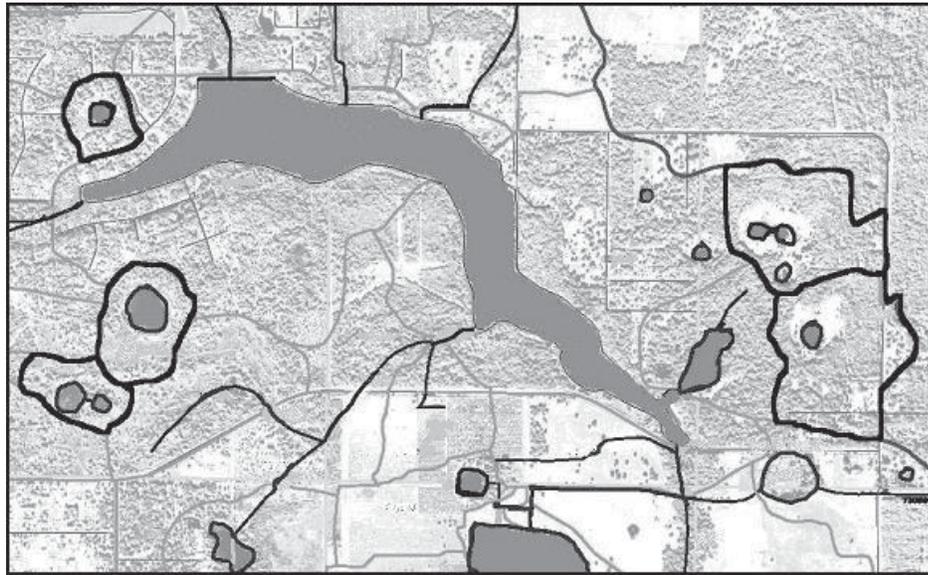
Closed depressions and internally drained basins also indicate potential direct interconnections of surface-water and groundwater. Approximately 2-3% of the Bell Creek Watershed is drained internally, i.e., the land drains to closed depressions that have no defined surface outfall. Within West-Central Florida, these closed depressions are widely known to be the result of land subsidence consistent with karst terrain. Karst landforms such as sinkholes can provide a direct pathway for conveying surface waters into the underlying aquifers. Using Arcview mapping software, we delineated the locations of closed depressions and their contributing sub-basins within the vicinity of Lake Grady, as illustrated in Figure 5.

**Figure 5:** Internally drained closed basins within the vicinity of Lake Grady. Bold lines denote closed basins.

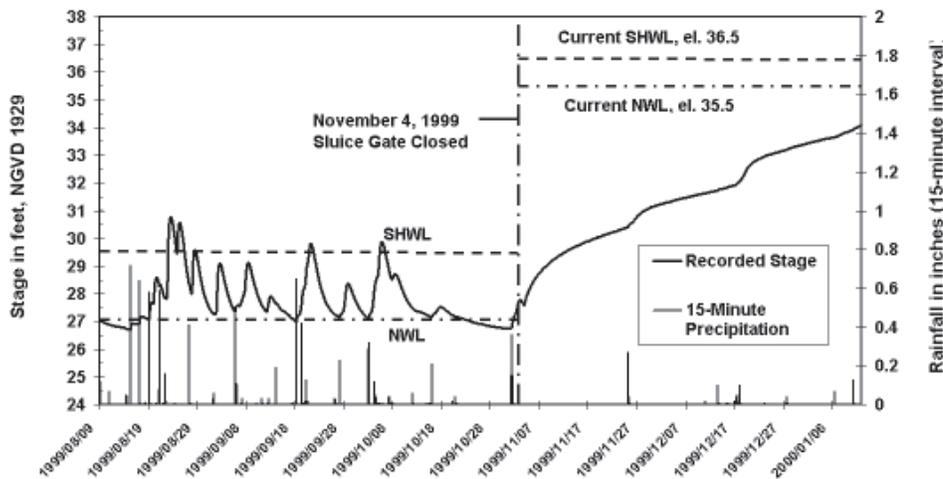
Figure 6: Lake Grady stage elevations and precipitation data.

We provide a graphical comparison between the uncontrolled fluctuations of the “pre-structure” system and the design lake elevations of the current structure in Figure 6. The recorded hydrograph is from a stage recorder located on Lake Grady, immediately upstream of the dam structure. The stage and precipitation data were recorded in 15-minute intervals over a 5-mo. period by Hydrogage, Inc., as part of the data-collection effort for the Alafia River Watershed Management Plan commissioned by Hillsborough County (Parsons, 2002).

The left side of the graph shows the response of Bell Creek to a series of small rainfall events

occurring in August, September, and October 1999. Based on this hydrograph, we estimate the normal water level (NWL) of Lake Grady prior to closure of the sluice gate to be 27.1 ft, and the seasonal high-water level (SHWL) to be approximately 29.5 ft. Although the rainfall amounts over the next nine weeks following closure of the sluice gate in November 1999 added up to less than 3.2 in., the response of the lake stage was a pronounced continuous upward trend corresponding to rapid filling of the lake. This would indicate a significant baseflow contribution to either the lake or to the stream network, or both. Unfortunately, the gaging station was discontinued on January 11, 2000. Nevertheless, we can use the current design NWL and SHWL of 35.5 ft and 36.5 ft, respectively (dashed in Fig. 5), to compare with the pre-structure levels. Based on a unit-weight of water equal to 62.4 lb/ft<sup>3</sup>, we calculate that the 8.4-ft. increase in normal water level due to the filling of Lake Grady would correspond to a hydrostatic pressure increase of approximately 3.5 psi on the lakebed.

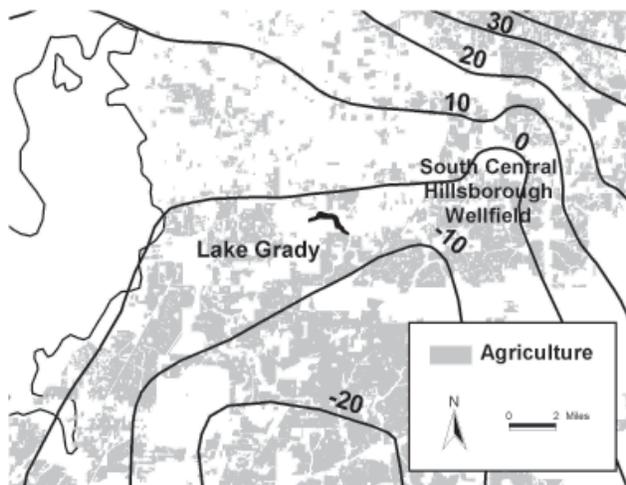
**Figure 7:** Potentiometric surface May 2000.

The drought of 2000 prompted an increase in groundwater withdrawals in the area from a nearby county well field approximately 4 mi east of Lake Grady and from agricultural irrigation south of Lake Grady. The potentiometric surface of the Floridan aquifer was approximately 5 ft below NAVD during the spring of 2000. Groundwater levels at monitor wells associated with the South Central Hillsborough wellfield showed Floridan aquifer levels 5–7 ft below NGVD during the spring months of 2000. The configuration of the potentiometric surface during the spring of 2000 includes a significant depression associated with this rather large area of agricultural irrigation (Fig.7). The wellfield is associated with a more localized depression away from Lake Grady.

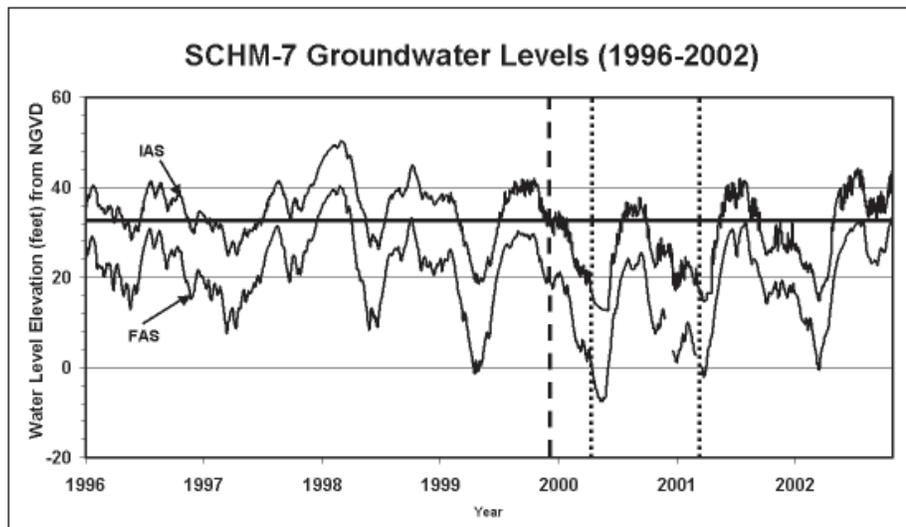
Groundwater levels in and around the study area were at historical lows in March 2000. We use the records from SCHM 7, which is 4 mi east of Lake Grady, to estimate the potentiometric surfaces of the Intermediate Aquifer System (IAS) and Floridan Aquifer System (FAS) at the Lake. As shown in Figure 8, the water levels in the aquifers drop below the lake bottom during the dry season regularly, but, during the drought of 2000, the difference was particularly large. Figure 8 also shows that during the wet seasons the level of the IAS was above the bottom lake, meaning that there was baseflow into the lake, and this would explain why the lake filled during the drought.

From comparison of the elevations of the lake bottom and the potentiometric surface of the FAS, we conclude that the difference between the two at the time of formation of Sinkholes #2 and #3 was approximately 30-35 ft.

**Figure 8:** Groundwater levels in SCHM-7. FAS denotes potentiometric surface in Floridan Aquifer. IAS denotes Intermediate Aquifer water levels. Solid horizontal line denotes elevation of lake bottom at Sinkhole #2. First dashed vertical line denotes closure of sluice gate on November 4, 1999. Second and third lines denote development of Sinkhole #2 and #3, respectively.
